External Communication						
Date:	7/27/2016	Customer:			Process	Evaluation
<input checked="" type="checkbox"/> Product <input type="checkbox"/> Process:		DSU-H	Lot #	PI15/0251	Part #	70-0285
Subject:	Evaluation of 2 DSU-H filters from					
Message:						
<p>An evaluation was performed on 2, DSU-H filters that were installed at [REDACTED]. Flow rate and backwashing was performed on both filters.</p> <p>The first step was to connect the filters to a lab sink, prime them, and then run water through the filters at 50psi. The flow rates were then taken for one minute. The flow rates for the [REDACTED] filters were 1 L/min and 1.5L/min respectively. This is a 90% decrease and an 85% decrease in flow rate respectively in comparison to the expected flow rate of a DSU-H filter, which is 10L/min.</p> <p>The next step was to backwash the filters which is done by connecting the filter outlet to the lab sink instead of the inlet side as done for flow rate testing. The water exiting on the inlet side was then captured for both filters. Image 1 shows the backwashing results as the 2 containers on the left are the unfiltered water from the backwash, and the 2 containers on the right are the filte

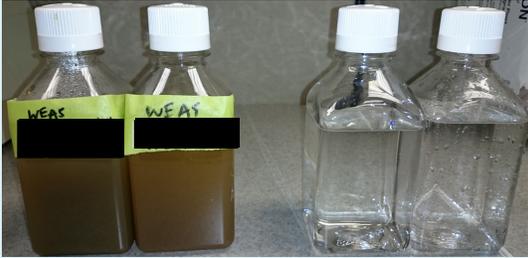
Image 1				Image 2

External Communication						
Date:	7/27/2016	Customer:			Process	Evaluation
<input checked="" type="checkbox"/> Product <input type="checkbox"/> Process:	DSU-H	Lot #	PI15/0251	Part #	70-0285	
Subject:	Evaluation of 2 DSU-H filters from					
Conclusion:						
<p>Image 1 and Image 2 clearly illustrate the performance of both DSU-H filters installed at [REDACTED]</p> <p>Image 1 shows the cumulative unfiltered water from both install dates compared to the filtered water from the DSU-H filters. The filtered water is clear in both filtered water containers.</p> <p>Image 2 further demonstrates the positive impact of the DSU-H filters and the unique dual stage barrier. This single filter was cut open to show the discoloration of the first fiber bundle compared to the white second fiber bundle. The discolored water (likely bacteria and other particulate) was retained in the first fiber bundle leaving the second bundle completely untouched, which explains the coloration difference. The water feeding the filters were so polluted that it caused irreversible fouling of the filter membrane that even after backwashing the filter, the flow rates were still not increased significantly.</p>
